Repair of damages in zinc layers

This information sheet describes the methods generally used for carrying out repairs and provides instructions on how to perform it. The information sheet also describes the requirements and guidelines specified by the standard EN ISO 1461 for carrying out repair work.

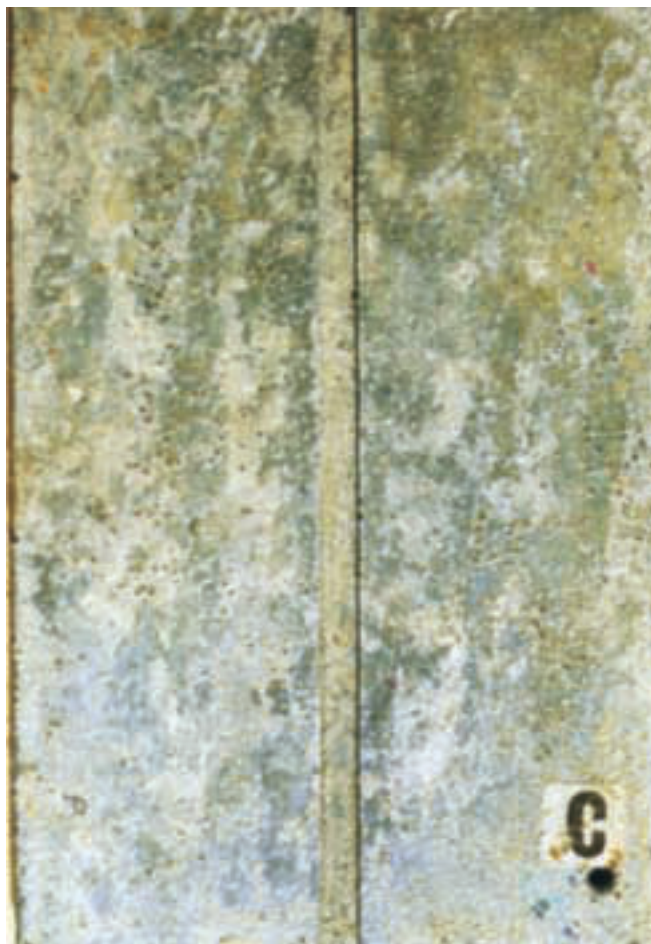
A 6 mm-wide cut groove through a 60 µm-thick zinc coating on steel and exposed for 5 years in a heavy industrial environment in Holland. Note the coating of zinc salts in the groove which has not been attacked by corrosion. (Photo: J F H van Eijnsbergen).
