Wet-storage stain - why is it formed? How to avoid it?

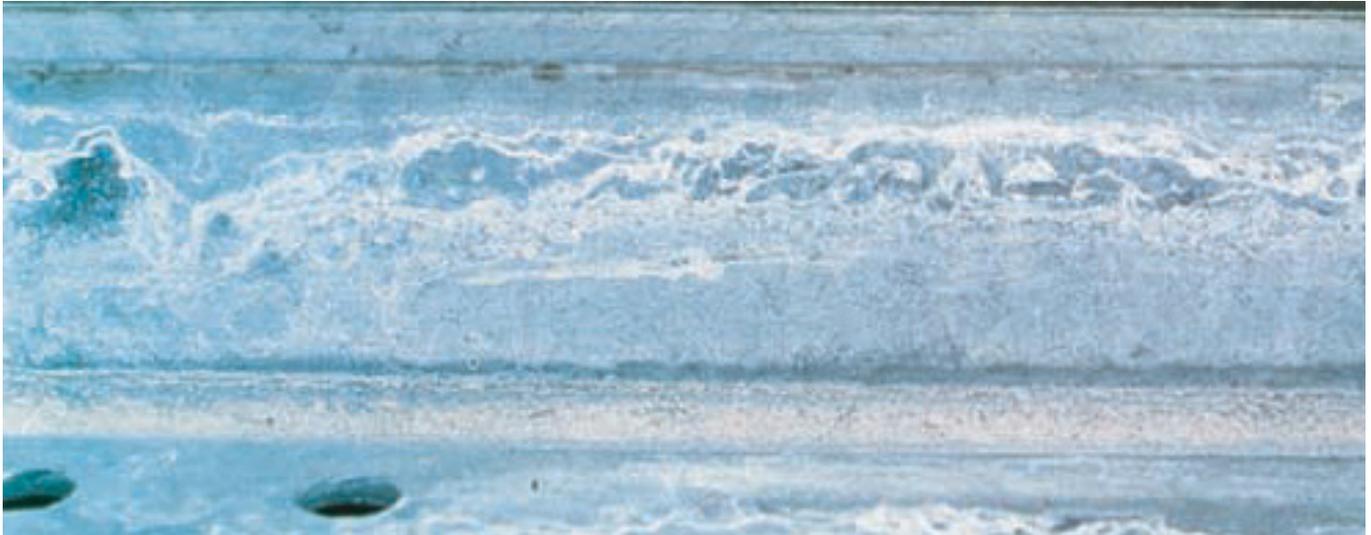
Figure 1. Wet-storage stain on closely joined angle irons after outdoor storage.

Wet-storage stain, or white rust, is the term for the white, flouy and loose corrosion products shown in Figure 1. White rust is preferably formed on newly galvanized surfaces.

White rust only forms if there is water on the galvanized surfaces, e.g. rain or condensation. If the galvanized steel are stacked tightly, the attack will primarily take place in gaps where ventilation is poor.

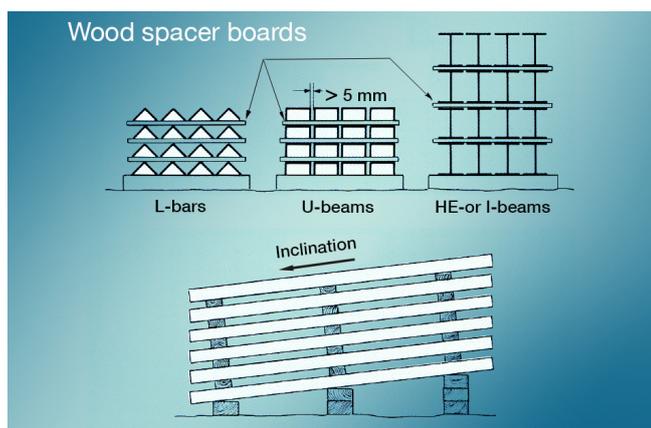
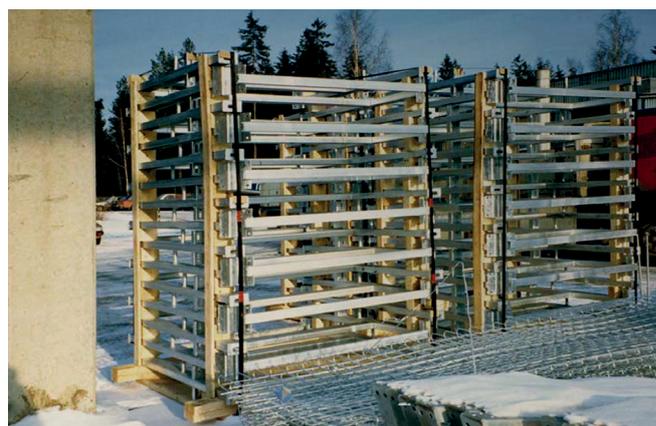
Figure 3. The galvanized steel should be stored with a slope and turned so that water accumulations are avoided. Spaces are placed so that no gaps occur and so that all surfaces are ventilated.

Outdoor storage items covered with tarpaulin should also be stacked with spacers so that condensate, formed due to changing temperature, can be removed by air ventilation. The tarpaulin should therefore only act as a roof that protects against rain and snow.

The tarpaulin must not rest on the hot-dip galvanized steel and must allow air ventilation, for example through openings at the ends of the workpiece stack. Figure 2 provides suggestions for how hot-dip galvanized items can be stacked.
